Instructions on how to replace the keyboard mat on Gemini

In analysis with our factory, we concluded that the most likely cause for issues around keys sticking on the Gemini keyboard was the rubber/silicon keyboard mat under the Gemini key caps on the keyboard.

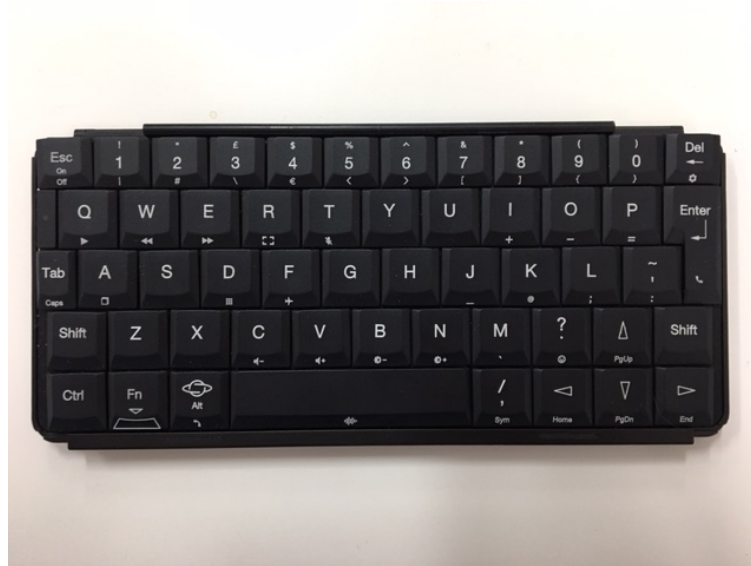
Photo 1: Photo of intact keyboard with all keys in place.

Before removing any keys, take a photo of how all the keys are laid out to help when eventually putting the keys back.

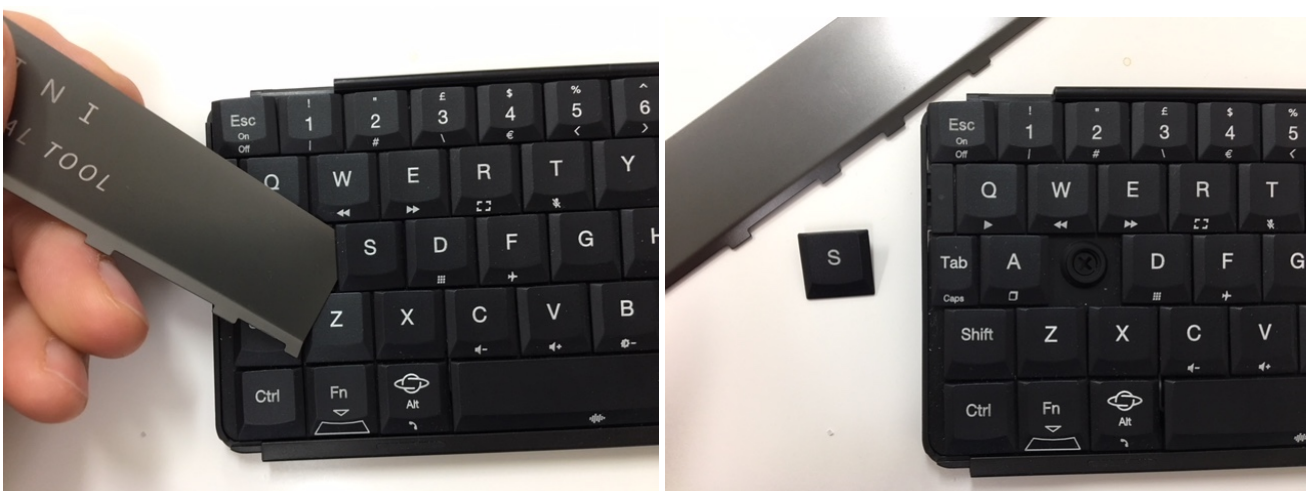
Photo 2 & 3: Photo of an example flat tool (eg Cover Removal Tool) under one of the keycaps and then the removal of the S key.

The keycaps on the keyboard all are designed to be removable. This is done by sliding a flat stiff bit of metal or plastic underneath the keycap and lifting up. See the below two images:

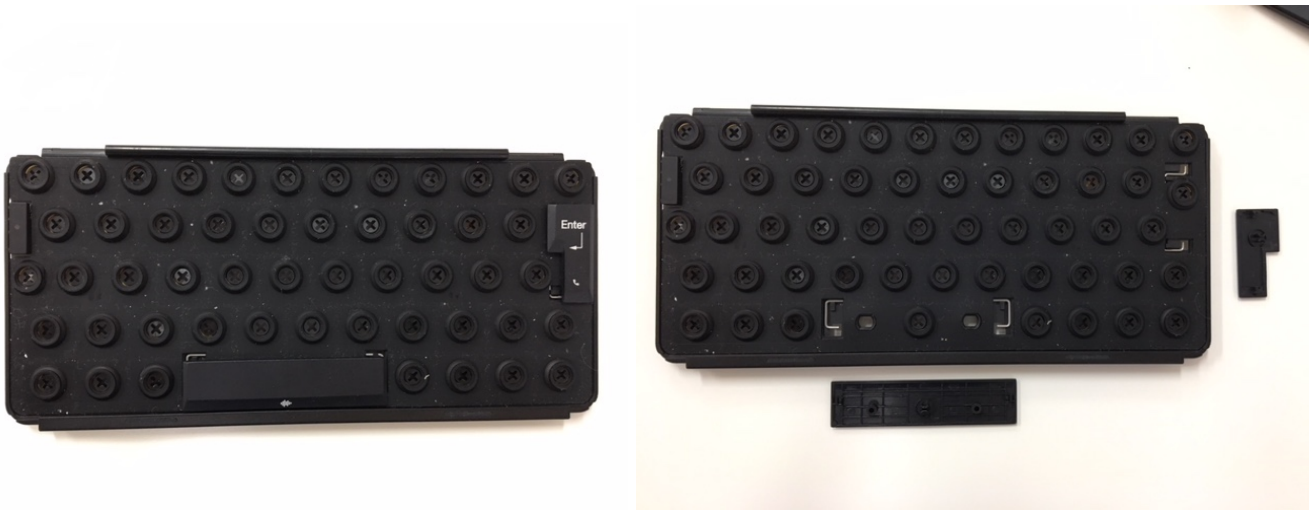
Photo 4 & 5: Photo showing the keyboard following removal of all keys apart from SPACEBAR and ENTER and the difference between the normal keys and SPACEBAR and ENTER keys.

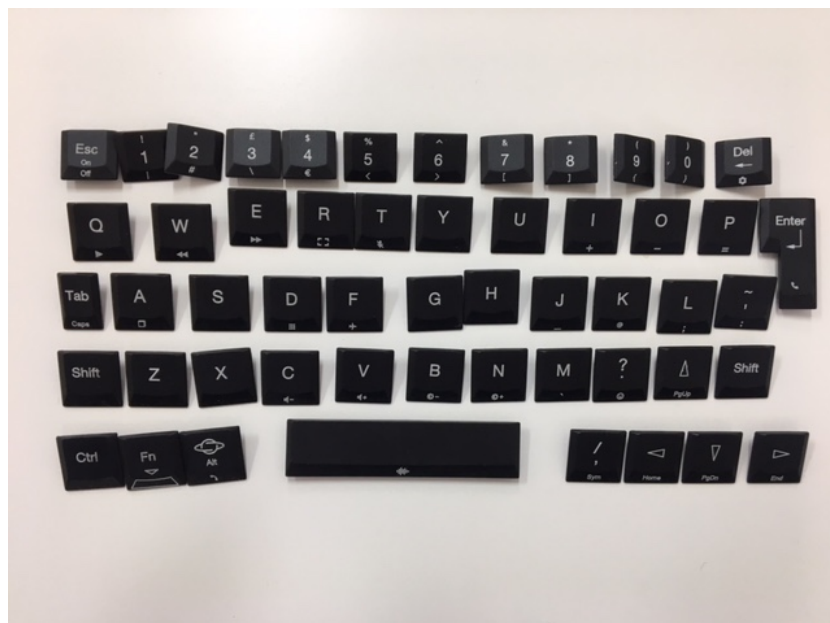
Photo 6: Photo of all removed keycaps laid out as they were on the original keyboard to aid reassembly.

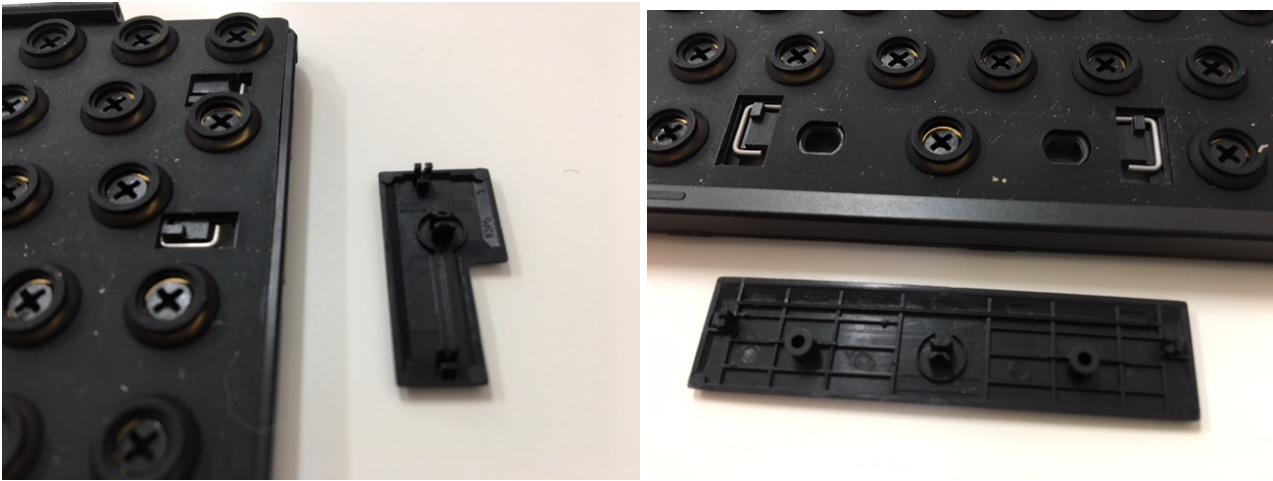
The only two keys that are slightly different are the ENTER and SPACEBAR. This because, whilst the removal mechanism is the same as the other keys, these two keys have secondary clips on the keycap that clip onto a metal wire on the keyboard.

Photo 7 & 8: Photo showing the ENTER & SPACEBAR keys removed but illustrating the two key clips used to clip onto the metal wire.

Specifically, for the ENTER and SPACEBAR keys, please now check the two plastic clips on the underside of the keys to ensure they are still intact and not damaged as we had noticed on occasion that these clips were bent in some production units which could also lead to compromised SPACEBAR and ENTER performance. If you notice any anomalies to the plastic clips on the underside of the SPACEBAR and ENTER keys, please get in contact with Planet Computers again (hello@planetcom.co.uk).

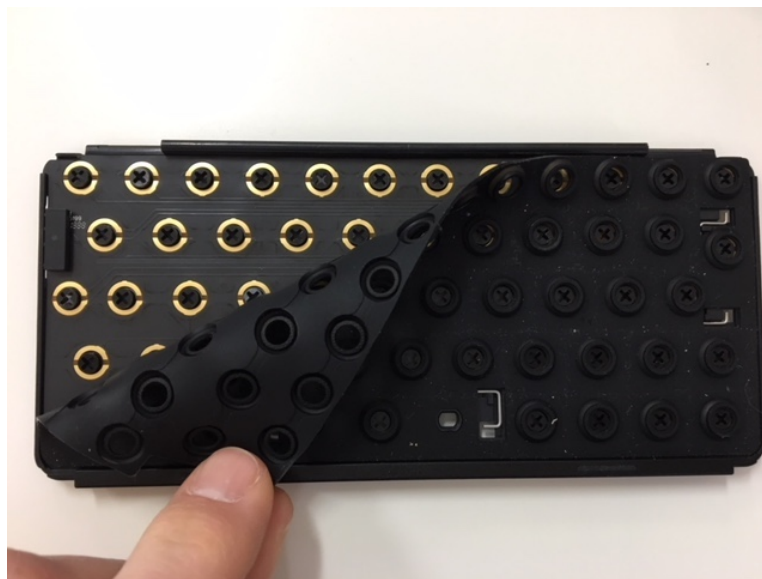
Photo 9: Photo illustrating the removal of the keyboard mat exposing the keyboard flexi.

Now all the keys have been removed, the silicon keyboard mat should be easy to lift off. Now replace the keyboard mat with the enclosed mat.

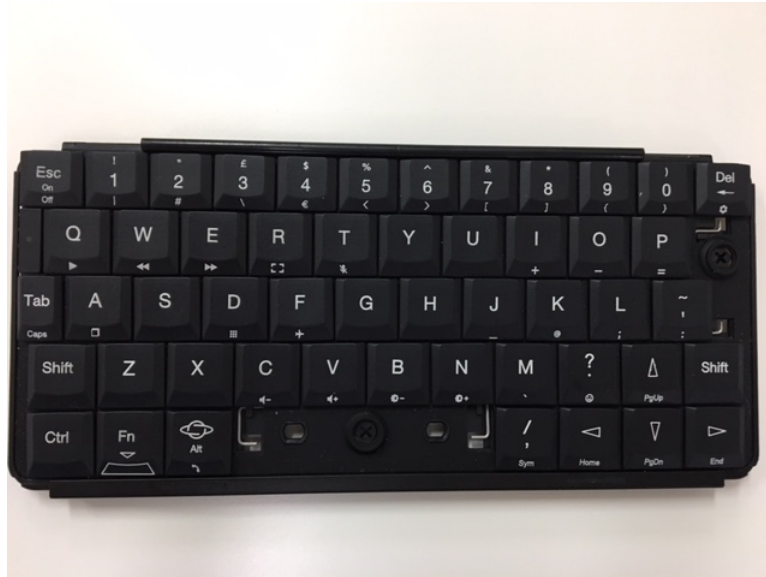
Photo 10: Photo showing the keys all back reassembled onto the keyboard with only the SPACEBAR and ENTER keys left to reapply..

One by one, put back all the keys in the way they were originally, based on the photo you originally took, leaving the SPACEBAR and ENTER keys until last.

When adding the SPACEBAR and ENTER keys back, ensure that you first clip the keys onto the metal wire and then push the key back into the keyboard. This is a bit fiddly.

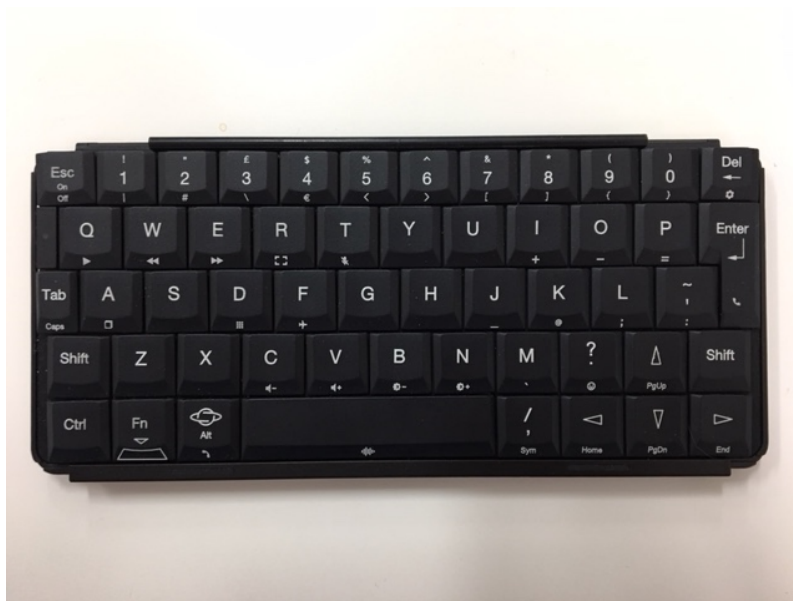
Photo 11: Back to the full keyboard layout.

Now repeatedly press all keys a number of times to check function and run the keys in with the new mat.
